**Needs Assessment of Accessible
Performance Spaces in the City of
Vancouver and Accessibility Audit:
Final Report**

March 24th, 2017

The accessibility audit checklist was piloted during an audit of the Firehall Arts Centre which took place on October 7th, 2016. As part of this audit, the SPARC BC consulting team along with staff members from Realwheels, Kickstart Disability Arts and Culture, and the Firehall Arts Centre used the checklist to inform an accessibility audit of the Arts Centre. The purpose was to test the checklist and to identify if there were any gaps to be addressed.

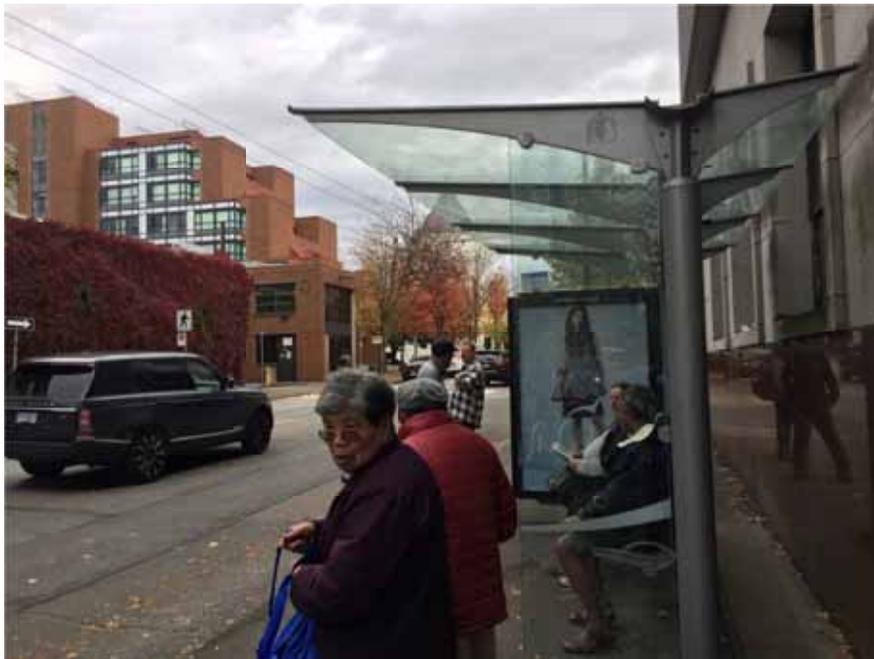
- A bench which provides space for someone with limited mobility to sit and rest;
- A clear space alongside the bench where someone using a wheelchair can pull up and rest;
- A bus shelter which protects people waiting for the bus from the rain and wind.

Figure 2: Bus Shelter at Main and Cordova

Recommendation: Since the other bus stops lack these accessibility features; it may be worthwhile to approach the City of Vancouver to ask if they would consider creating accessible bus shelters at these locations in the future.

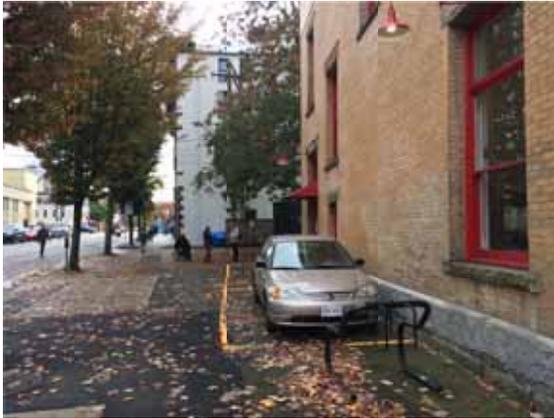
Parking: Overall, there is a limited supply of parking at the Firehall Arts Centre, since it does not have its own parking lot. This is largely due to the fact that the Centre was originally designed as a Firehall, not a theatre. There are a small number of metered parking spots available in front of the theatre on Cordova Street; however, these spots have a time limit. There are also a couple of parking stalls that have been created alongside the building facing Gore Avenue. For those who are able to walk longer distances, there is an Easy Park parking lot at 107 East Cordova and an Impark Lot at Main and Powell.

Figure 3: Existing Parking Spaces alongside Gore Avenue

Providing accessible parking at the theatre would improve access for both people who work at the theatre and theatre visitors. The Firehall Arts Centre may wish to explore the feasibility of offering disability parking spaces that can be reserved in advance. Some potential locations include the two parking spaces on the side of the building by Gore Avenue as well as parking in the Courtyard behind the theatre.

In the future, if there is an opportunity to add more parking in the immediate vicinity of the Firehall Arts Centre, it would be beneficial to provide designated accessible parking stalls for people with disabilities. A good rule for ensuring that there is enough disability parking is to designate 4% (or 1 out of every 25 stalls) as accessible. In order for a parking stall to be fully accessible, it needs to have the following accessibility features:

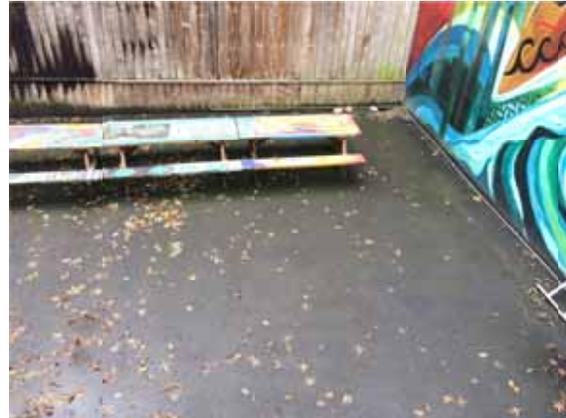
Figure 4: Courtyard Behind Firehall Arts Centre

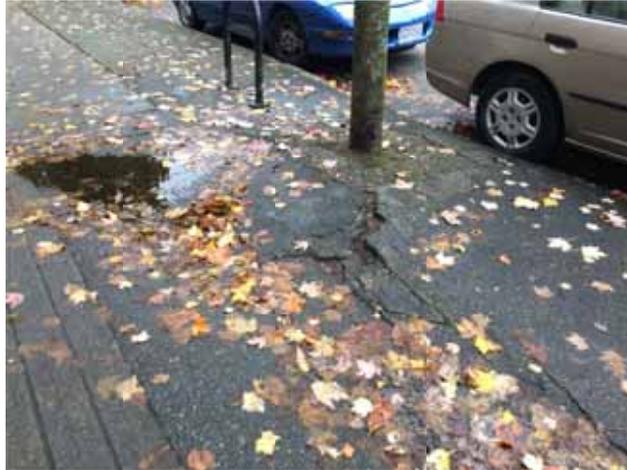
- Older sidewalks with cracked pavement that can create a hazard for people using mobility devices (particularly mobility devices with small wheels);
- Dips in the sidewalk where puddles and leaves accumulate.

Figure 5: Cracked pavement, puddles and leaves on sidewalk in front of Firehall Arts Centre

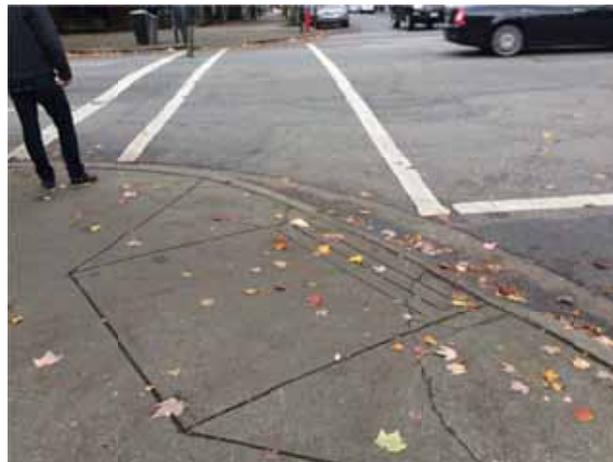
We also noted that some of the nearby intersections have curb ramps which provide access for people using mobility devices; however, the curb ramps do not line up with the path of travel across the street, which could be confusing and/or potentially unsafe for people with visual disabilities as they direct people out into the middle of the intersection.

Figure 6: Example of a Curb ramp that does not line up with the accessible path of travel at intersection

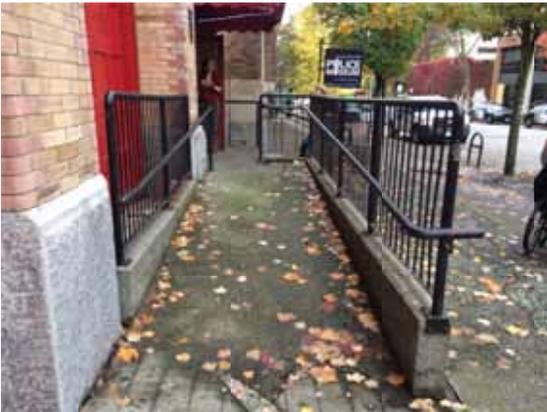
Figure 7: Ramp by main entrance

- There was cracked pavement as well as a pile of leaves at the base of the ramp both of which can create a hazard for people using mobility devices.
- The doorway is too narrow (30 inches) for people using larger mobility devices.

Recommendation: As part of future renovation plans, explore the feasibility of creating an accessible main entrance that provides access for people with disabilities to the box office, seating area, reception area and public washrooms.

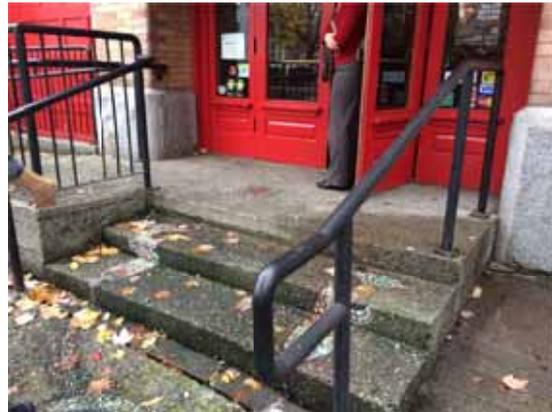
Figure 8: Stairs by Main Entrance

- Once a person using a mobility device goes up to the ramp and into the main entrance and gets their ticket from the box office, there is another flight of stairs. As a result, they have to use an alternate accessible entrance to enter the seating area of the theatre.

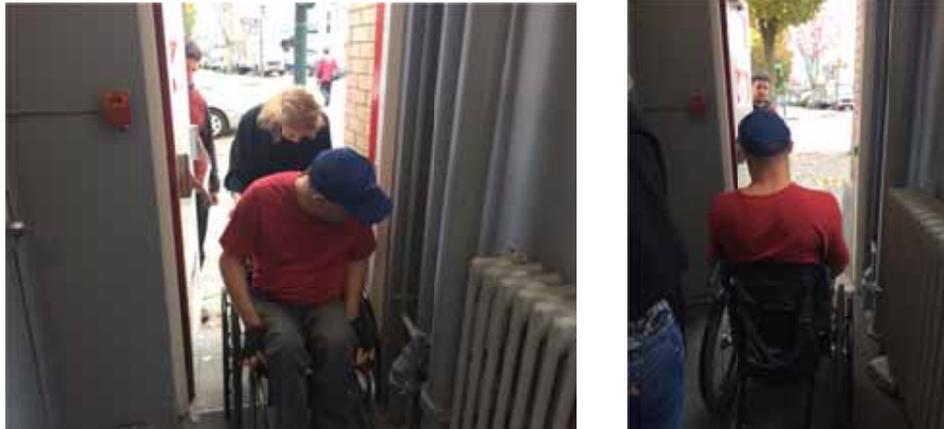
Figure 9: Accessible entrance for Firehall Arts Centre

Through creating an alternate accessible entrance for theatre patrons and performers with disabilities, the theatre has demonstrated a commitment to accessibility. However, there are some limitations with the current accessible entrance including:

- The cracked pavement at the base of the ramp;
- The steepness of the ramp is also a hazard and is challenging to use independently;
- The doorway is too narrow for people who use larger mobility devices;
- An individual requires staff assistance to use it and cannot enter and exit the theatre independently.

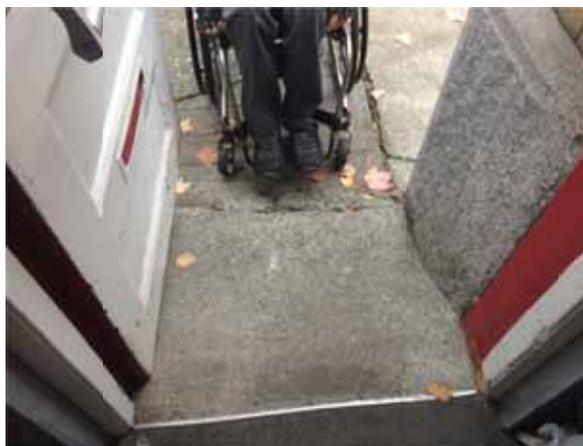
Figure 10: Cracked pavement at the base of the ramp

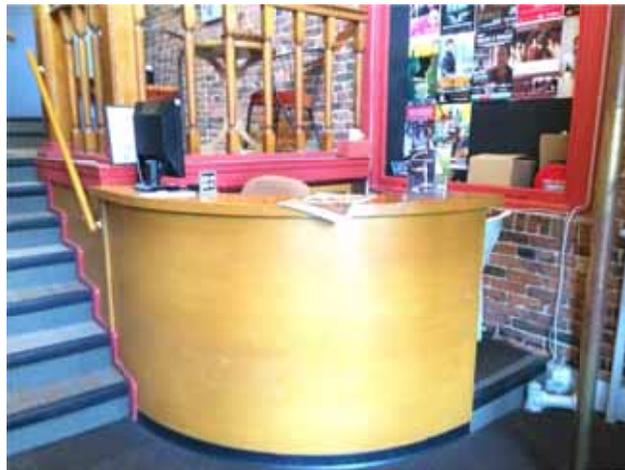
Box Office: The box office at the Firehall Arts Centre is located directly inside the main entrance of the theatre and can be accessed by someone using a mobility device. Some opportunities to enhance accessibility at the box office include:

Figure 11: Box Office

- Provide signage which directs visitors to the box office;
- Provide a wheelchair accessible service counter;

- Install a hearing loop or other Assisted Listening System which helps Hard of Hearing patrons communicate with box office staff;
- Provide training to staff so that people working at the box office are well trained on serving people with disabilities, are knowledgeable about the accessibility features the theatre can provide and can help to connect people with disabilities to available technology and resources;
- Provide a brochure of accessibility features that staff can share with visitors – This brochure should conform to large print standards.

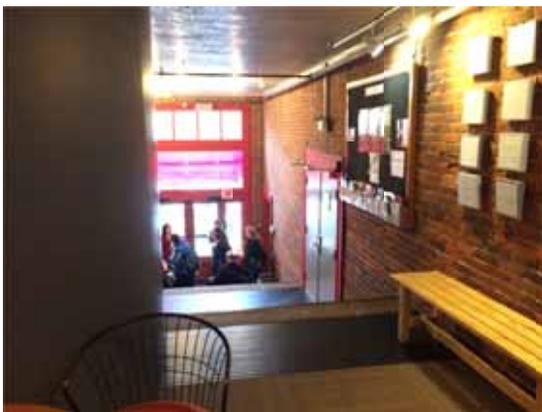
Figure 12: Staircase leading up to Concession Area

- Provide elevator access to this level as well as a wheelchair accessible washroom;
- Provide a wheelchair accessible counter that provides a lower counter section as well as knee space for someone using a wheelchair to be able to pull up to the service counter;
- Provide a Braille menu for people who are blind;
- Provide Captioned Television Screens which share important announcements to people who are Deaf and Hard of Hearing (e.g. 10 minute warning, updates about performance delays, emergency announcements);
- Provide staff training so that staff are well trained on serving people with disabilities;
- Provide a brochure with information about the various accessibility features that are available.

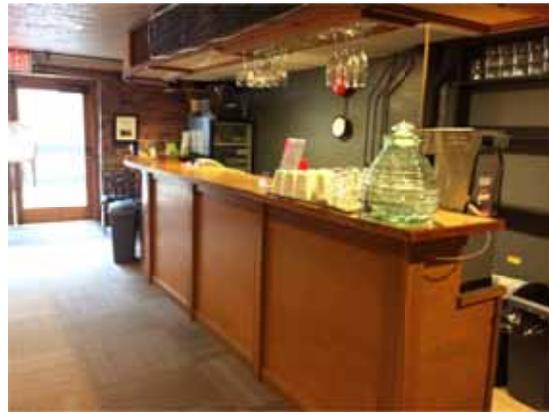
Figure 13: Main service counter at bar

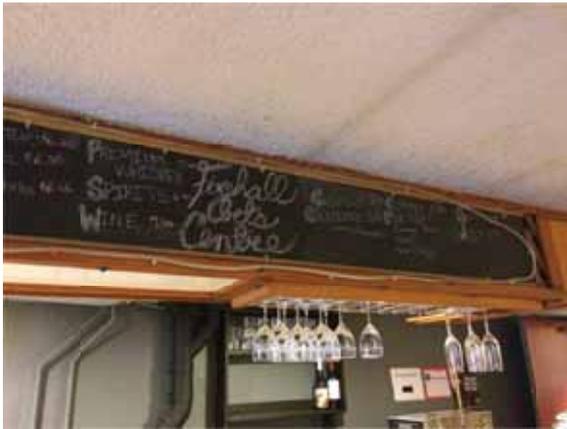
Figure 14: Overhead drink list

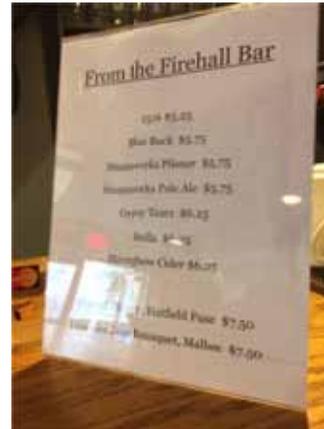
Figure 15: Large print drink list

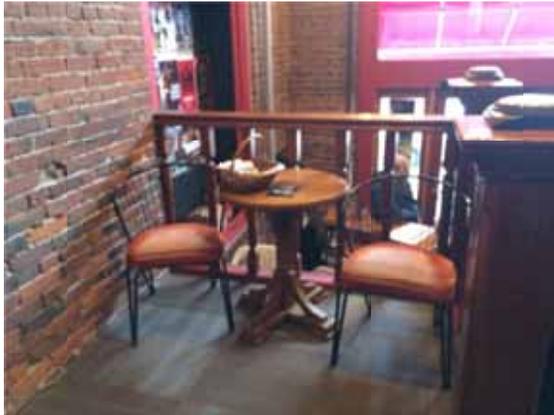
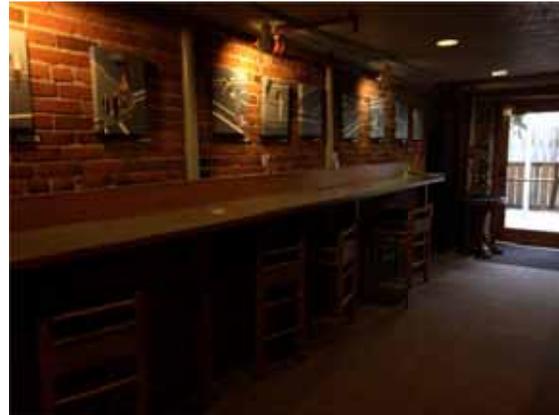
Figure 16: Seating options in reception/concession area

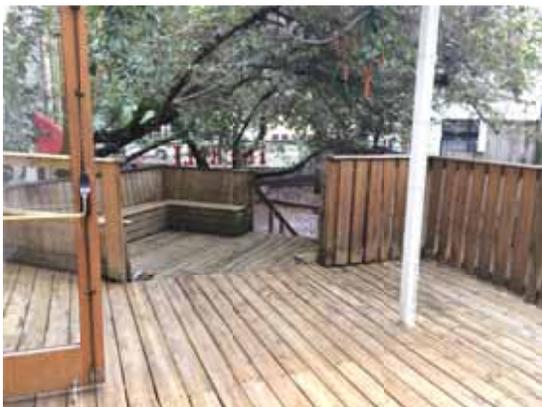
Figure 17: Outdoor patio seating area

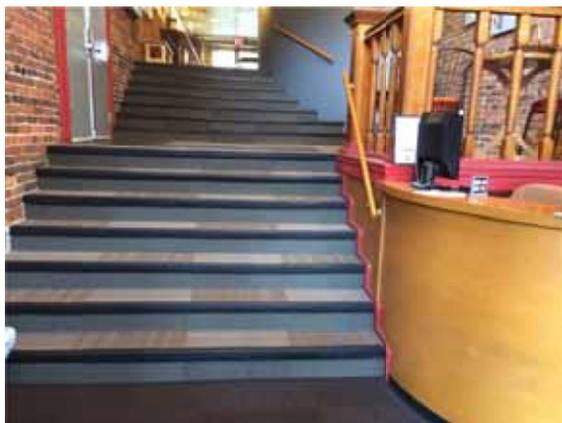
Accessible pathways and circulation: A fully accessible theatre would have accessible paths of travel connecting all key activity areas including the main entrance, box office, theatre seating area, concession area, washrooms, etc. The main limitation around this is that the Firehall Arts Centre does not have an elevator leading to the second level.

Figure 18: Staircase connecting box office to theatre and concession on second level

Recommendation: Explore the feasibility of installing an elevator which provides access to the second level of the Firehall Theatre

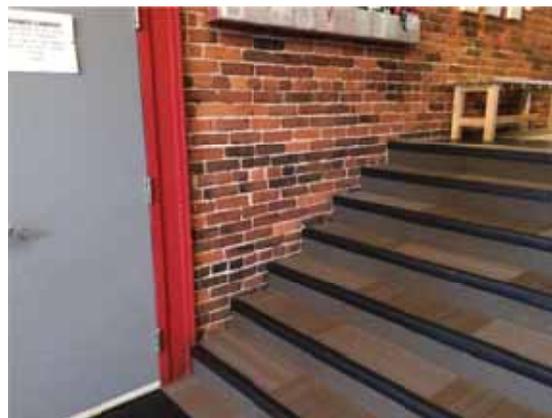
Figure 19: Staircase does not have handrails on both sides

- Provide handrails on both sides of the stairs (Note: there is a risk that people may grasp onto the display posted on the wall for extra support and inadvertently knock it off the wall).

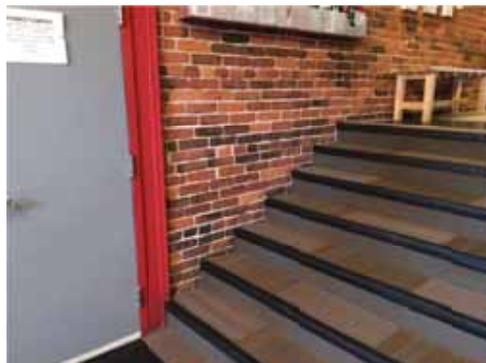
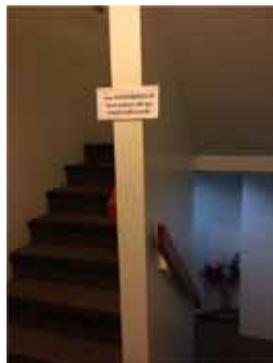
Figure 20: Staircases do not have handrails on both sides

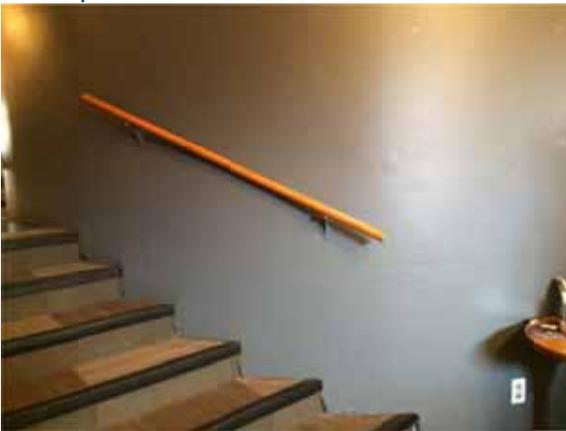
Figure 21: Handrail does not run the full length of staircase and does not level off at the top and bottom of the staircase.

- Provide handrails that run the full length of the staircase and level off at the top and bottom to indicate the end of the staircase;
- Keep the area alongside the wall at the top and bottom of the staircase clear of obstructions such as garbage bins and magazine stands since this obstructs the accessible path of travel for people with visual disabilities who are using the handrail and wall for guidance.

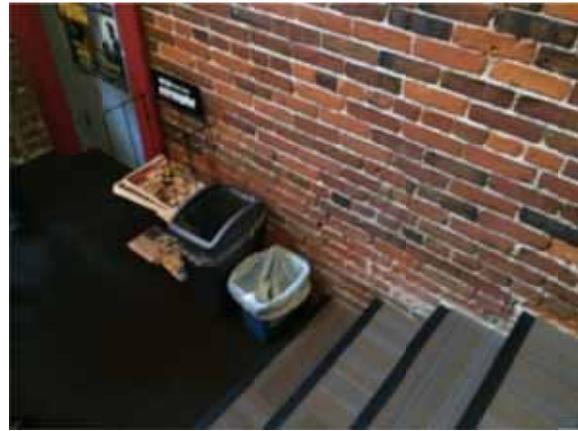
Figure 22: Garbage bins obstruct accessible path of travel at base of staircase

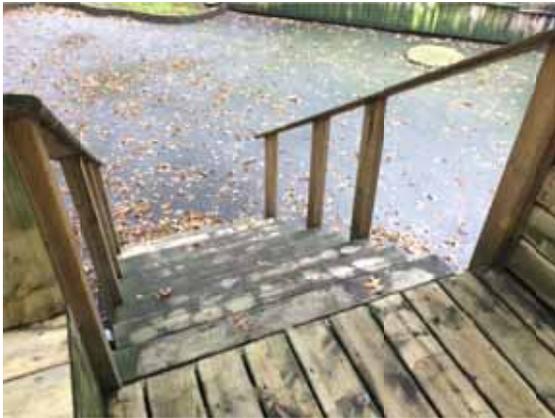
Figure 23: Stairs connecting outdoor patio area to rear courtyard lacks tactile warning strips & round handrails

- Use high colour contrast tactile warning strips on stair nosings and at the top of staircases to warn people with visual disabilities about a change in level (Note: the black tactile strip by entrance to the theatre seating area is confusing because it lines up with the doorway, not the top of the staircase).
- Provide handrails that are round and easy to grasp onto for people with limited hand dexterity

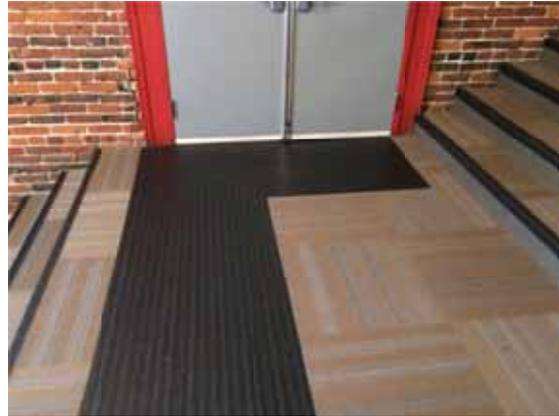
Figure 24: Confusing tactile warning strips by entrance to theatre seating area

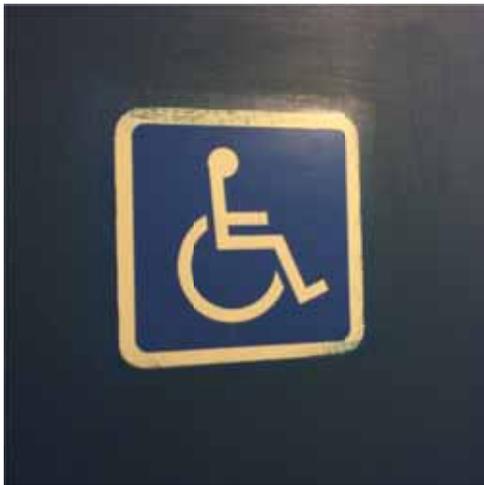
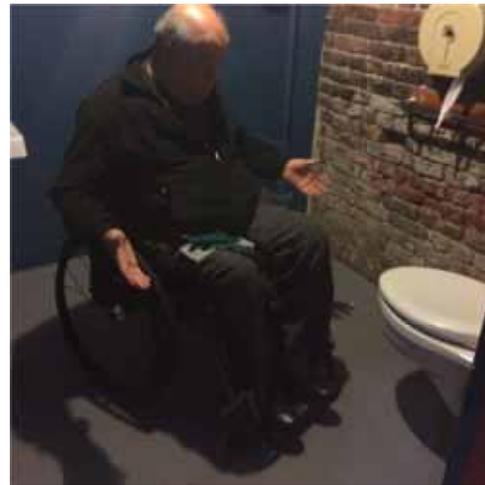
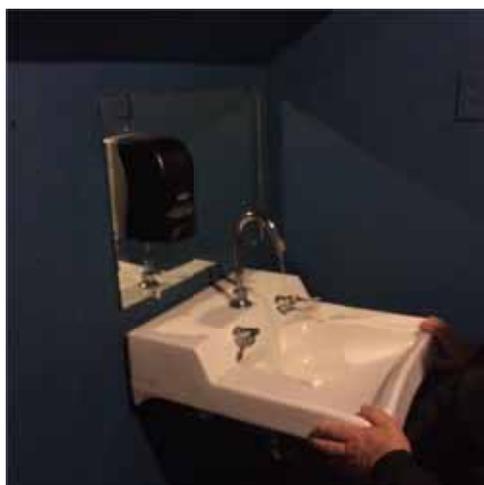
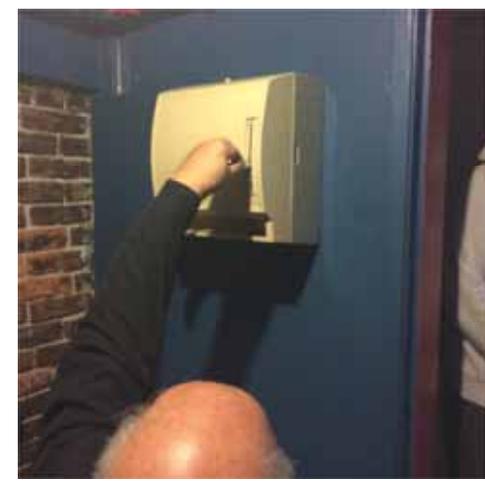
Figure 25: Accessibility features in universal washroom

Recommendation: Once elevator access is provided to the upper level where the upstairs washrooms and administrative offices are located, renovate washrooms with accessibility in mind. Some characteristics of fully accessible washrooms include:

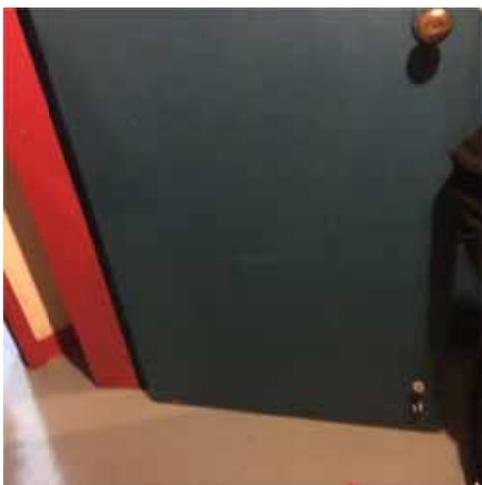
Figure 26: Washroom door with round handrail and without kick plate

- Install a sign with Braille and raised lettering
- Replace the round door handle with a lever style handle or automatic door opener
- Install a kick plate on the door to protect it from people using their feet to push open the door.

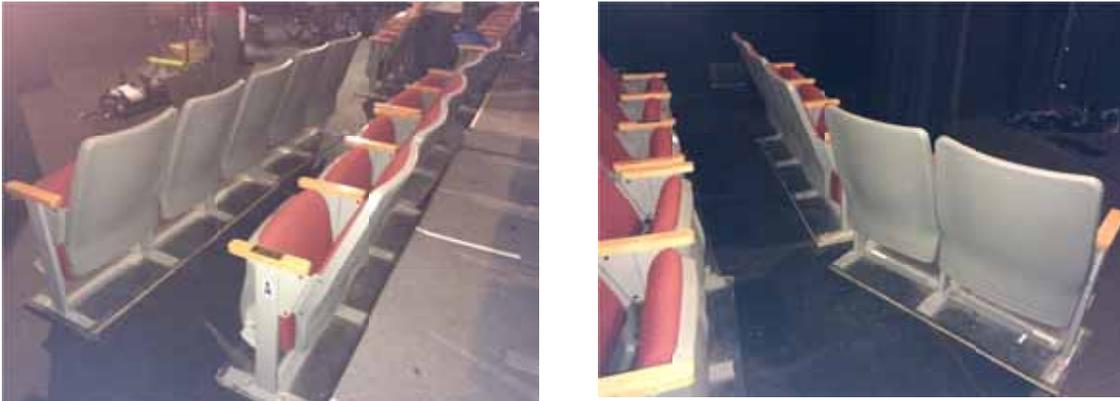
Seating options: Depending on the configuration used during the show, the number of seats in the Firehall Arts Centre ranges between 135-150 people. The first two rows of the seating are comprised of flexible seating that can be easily moved. As a result, it would be possible to provide a significant amount of accessible seating within the theatre.

Figure 27: Flexible seating in the first two rows

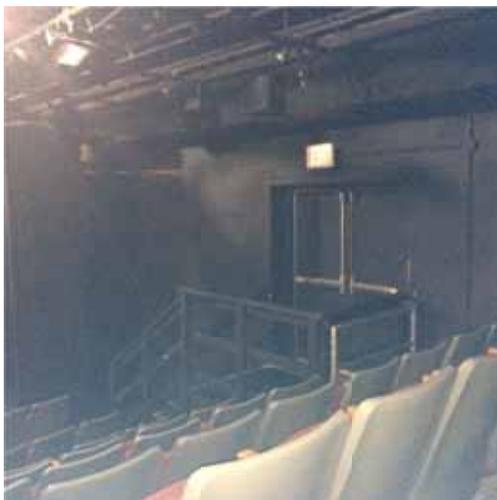
- Wheelchair access is only provided by an alternate side entrance to the theatre;
- To access an accessible public washroom, a staff member would have to accompany someone using a mobility device across the stage;
- The only wheelchair seating option available is at the front of the theatre because the rest of the seats are located up a flight of stairs

Figure 28: Entrance and staircase connecting main box office to theatre seating area

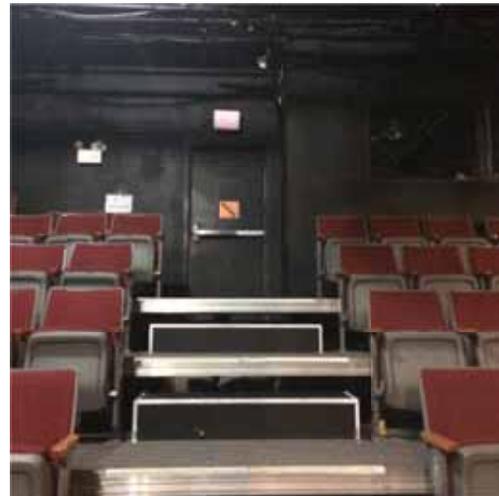
Figure 29: Latecomer seating in the back row up a flight of stairs

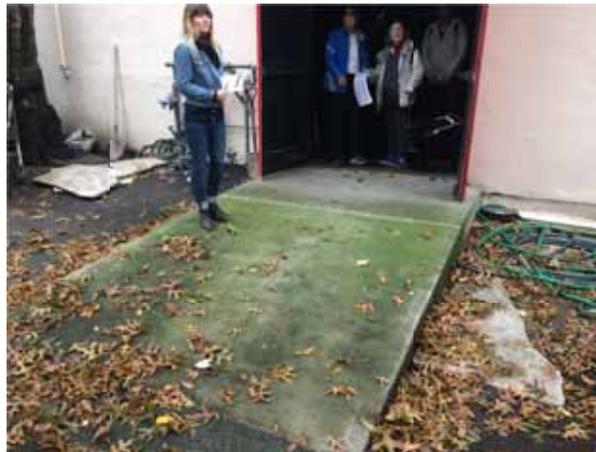
Figure 30: Alternate backstage entrance to theatre

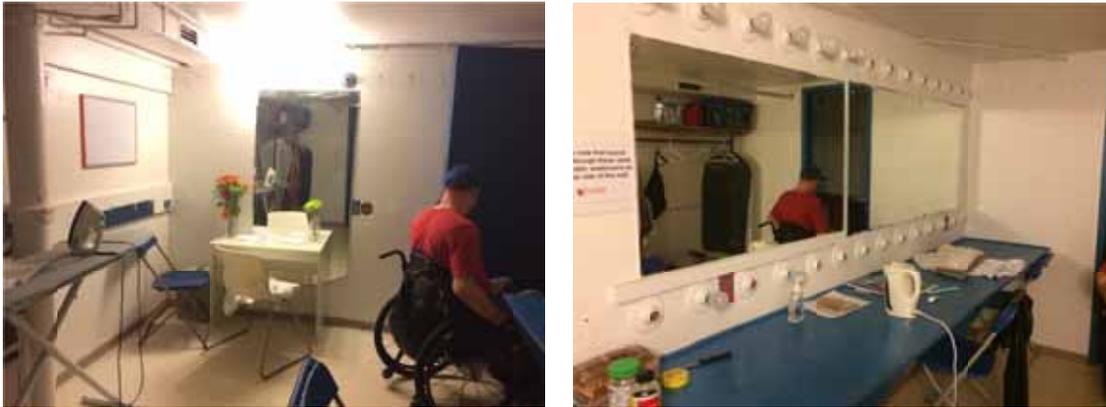
Figure 31: Ground Floor Dressing Room

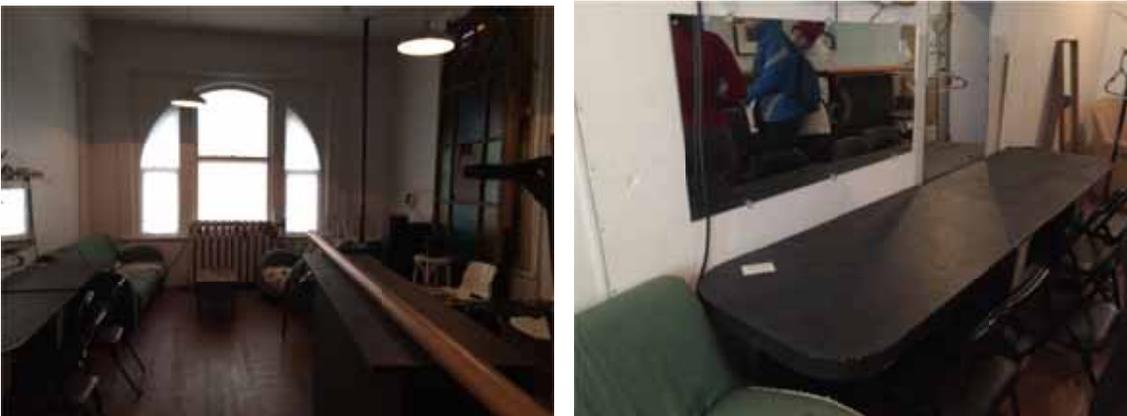
The main limitation with the Firehall Arts Centre is there are some additional spaces located on the second and third levels such as the concession area, administrative offices, another dressing room, and studio space that are not currently accessible because there is no elevator access to the second level.

Figure 32: Upstairs dressing room

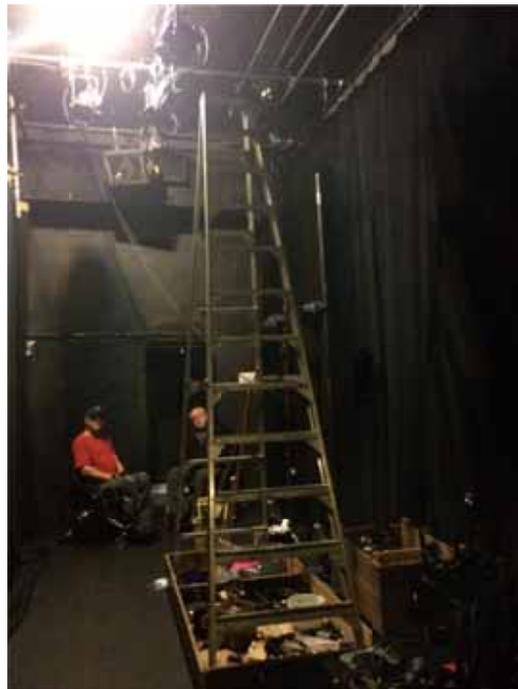
Accessible pathways: The current theatre set up would be challenging for technicians with disabilities because the tech control booth is located up a flight of stairs and tech staff have to climb ladders to adjust the lighting. Because of the scale of the theatre, other features such as a fly rail and suspension grid are not feasible.

Figure 33: Ladder providing access to overhead lighting equipment

Recommendation: One recommendation proposed by Firehall Arts Centre Staff that may work well in this context and other contexts is to set up an alternate tech control point using live video

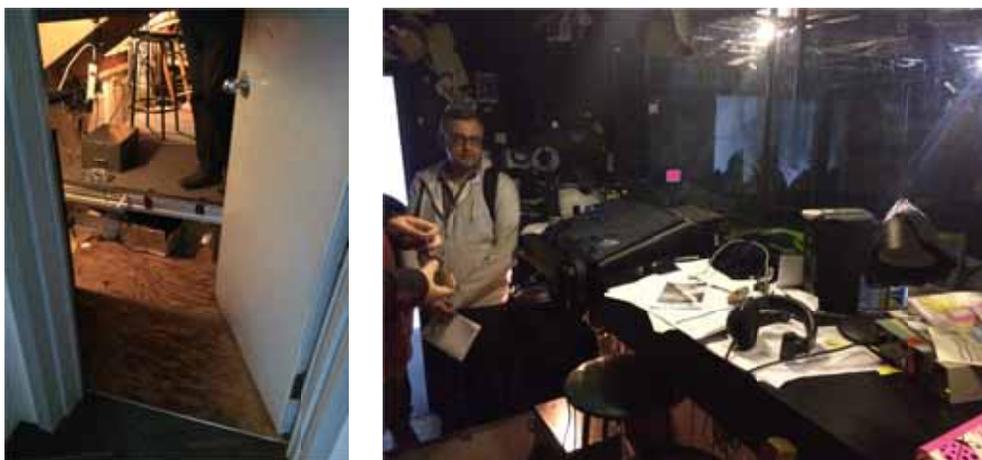
Figure 34: Technician Control Booth

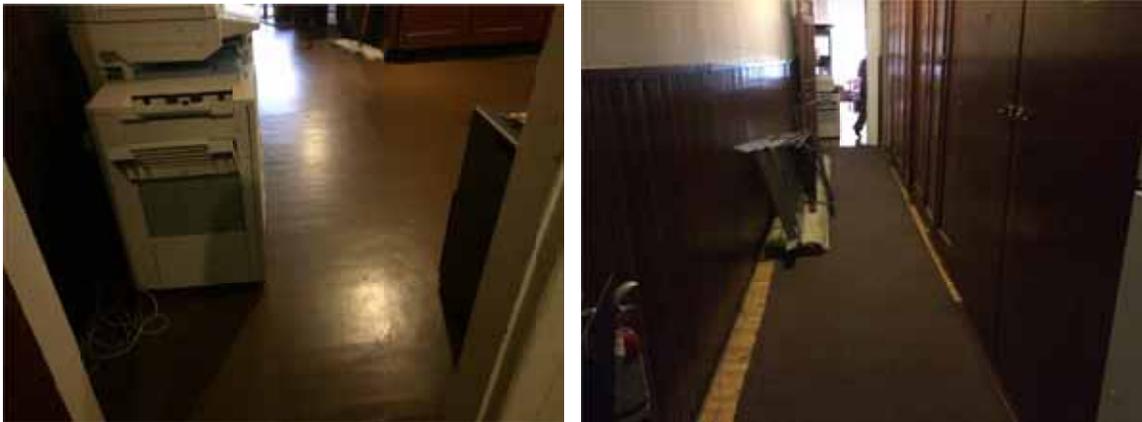
Figure 35: Pathways in Upstairs Administrative Offices

- Renovate the upstairs washrooms to be accessible for people with disabilities (see earlier section);
- Provide pathways that are clear of clutter and wide enough to accommodate people using mobility devices;
- Provide accessible workstations that can be adapted for people using mobility devices;
